**Industry:** Food Processing

**Application:** Tank Washing

**Product Descriptions:** Special TW Lance with Sanitary Fittings

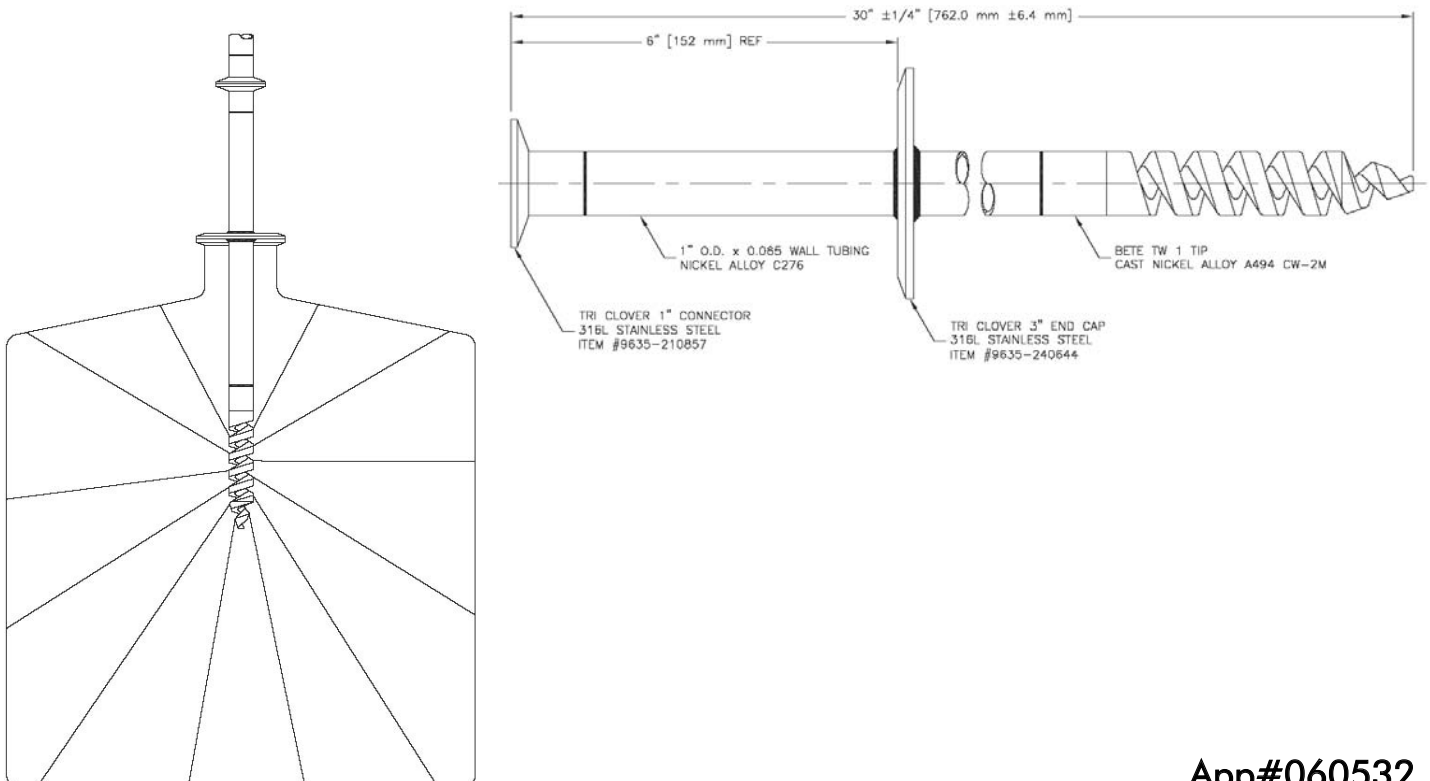
**BETE's solution:** Because this application required a corrosion-resistant material, BETE Applications Engineers selected nickel alloy C as the material of choice to stand up to the highly acidic environment in which the nozzles and lances would be submerged. Food processing applications such as these require a smooth lance assembly profile and the BETE TW-1s were machined to special dimensions to have the same outside diameter as the tube.
